Observations of Insulation Products in Flood Damaged Homes

Hurricane Harvey - Sept 2017

Author:

April 2018

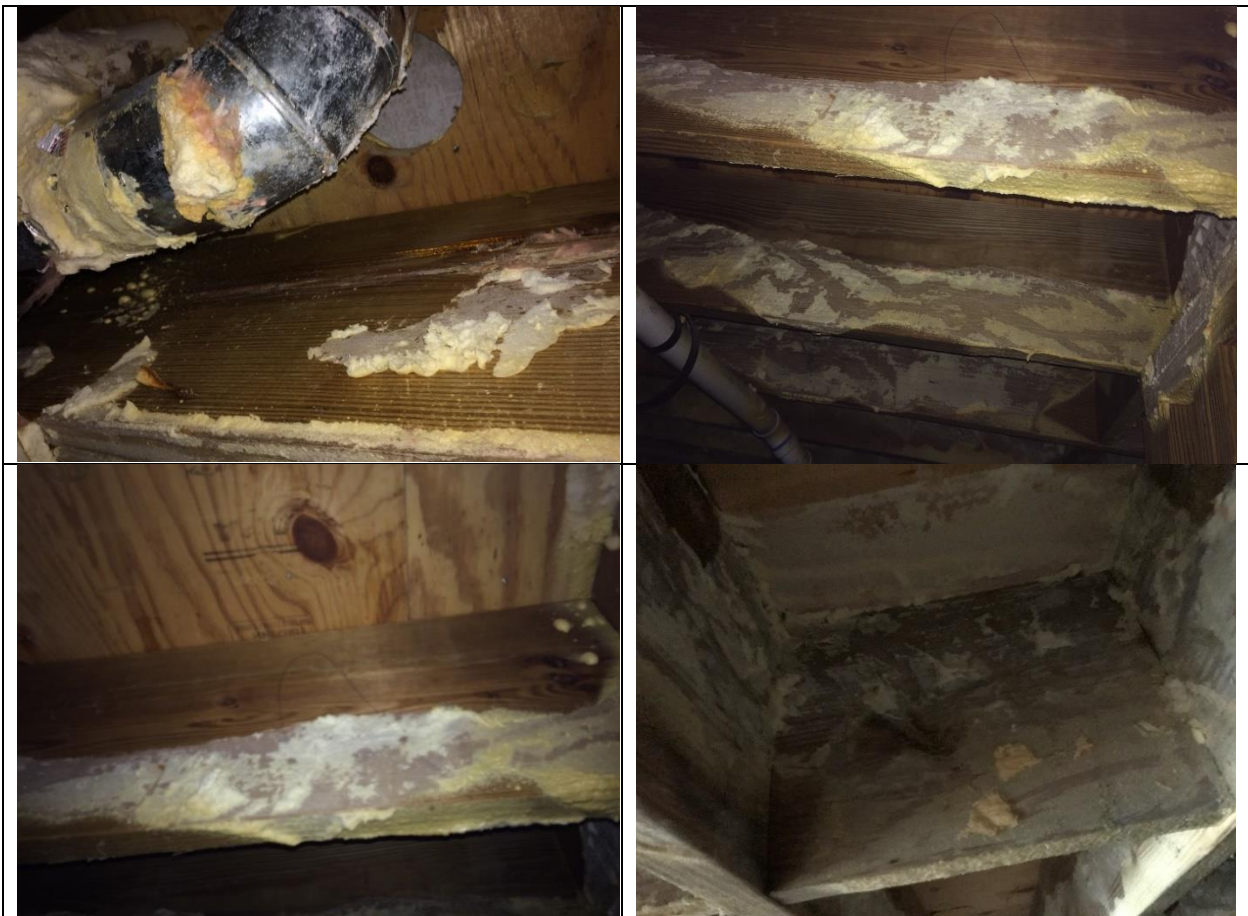
House #1: Insulation had been removed from the garage and subfloor of the house and placed in sealed plastic bags that were deposited on the curb. Inspection of the garage wall and floor framing, wall sheathing and subflooring showed they were dry with no visible signs of microbial growth. A sample of open cell SPF that did not appear to contain any moisture was collected from insulation contained in bags at the curb.

Insulation type	Insulation location	Floodwater max height	Floodwater duration	Microbial growth	Sheathing-framing condition
Open cell SPF with small amount of closed cell SPF	Under floor	Unknown	Unknown	Not visible	Dry and intact – OSB and plywood

Note how OC SPF appears to have been applied from above leaving air gap between top of foam and bottom of subfloor sheathing in pictures

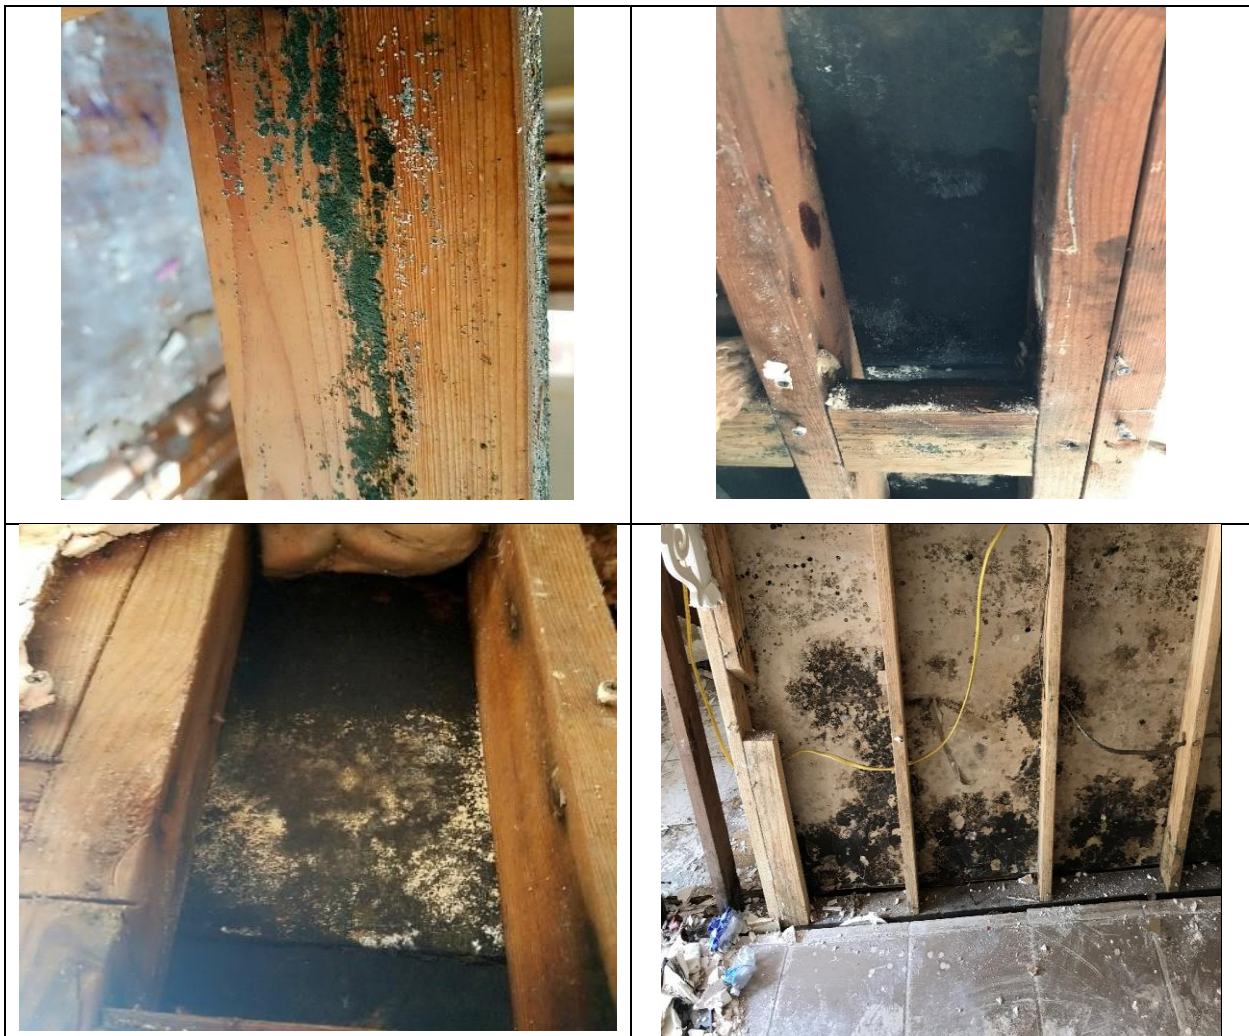
House #4: At this house, the team collected a sample of fiberglass batt insulation that was saturated. The sample was collected from a wall. There did not appear to be any wicking of moisture from flooded areas into areas that were not flooded. The floodwaters reached a height of 62 inches on this house. The gypsum board was being removed while the team was there. There was extensive mold growth throughout the house, including on the ceiling. Insulation and gypsum board had not been removed in a timely manner. The impregnated fiber board sheathing was also saturated and decomposing. This house flooded three times in the previous three years and the contractor on site said the owner was waiting for the insurance appraiser to recommend demolition.

Insulation type	Insulation location	Floodwater max height	Floodwater duration	Microbial growth	Sheathing-framing condition
Fiber glass	Interior walls	62"	14 days	Extensive throughout house in walls and on surfaces	Saturated and deteriorating, impregnated fiber board

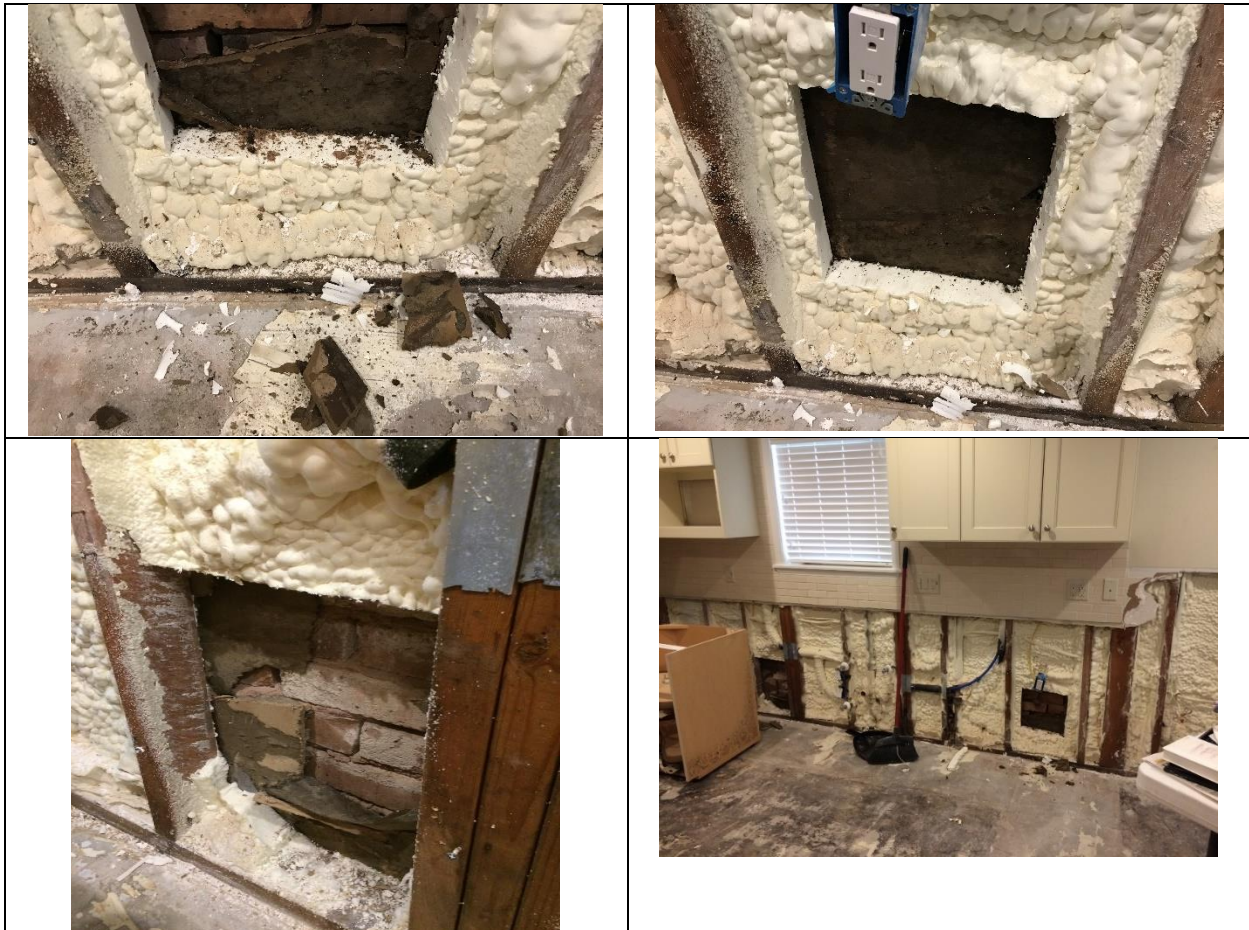
House #5: The team collected a sample of closed cell SPF from within a wall in a house where the remediation contractor had been running fans and dehumidifiers for at least two weeks in an attempt to dry the framing and sheathing. The insulation was approximately two inches thick, sprayed adjacent to exterior gypsum sheathing over brick cladding. There was an inconsistent air space between the exterior of the gypsum board and the interior side of the brick. The foam did not contain any significant amount of moisture (6 grams moisture in a ten inch by ten-inch sample two inches thick). The gypsum was saturated and decomposing after two weeks of unsuccessful attempts to dry the house. There was significant microbial growth on the framing and sheathing. The floodwaters reached a level about 27 inches above floor grade on this house.

Insulation type	Insulation location	Floodwater max height	Floodwater duration	Microbial growth	Sheathing-framing condition
Closed cell SPF	Interior walls	27"	7 days	Moderate to extensive on wall sheathing and framing	Saturated and deteriorating exterior gypsum

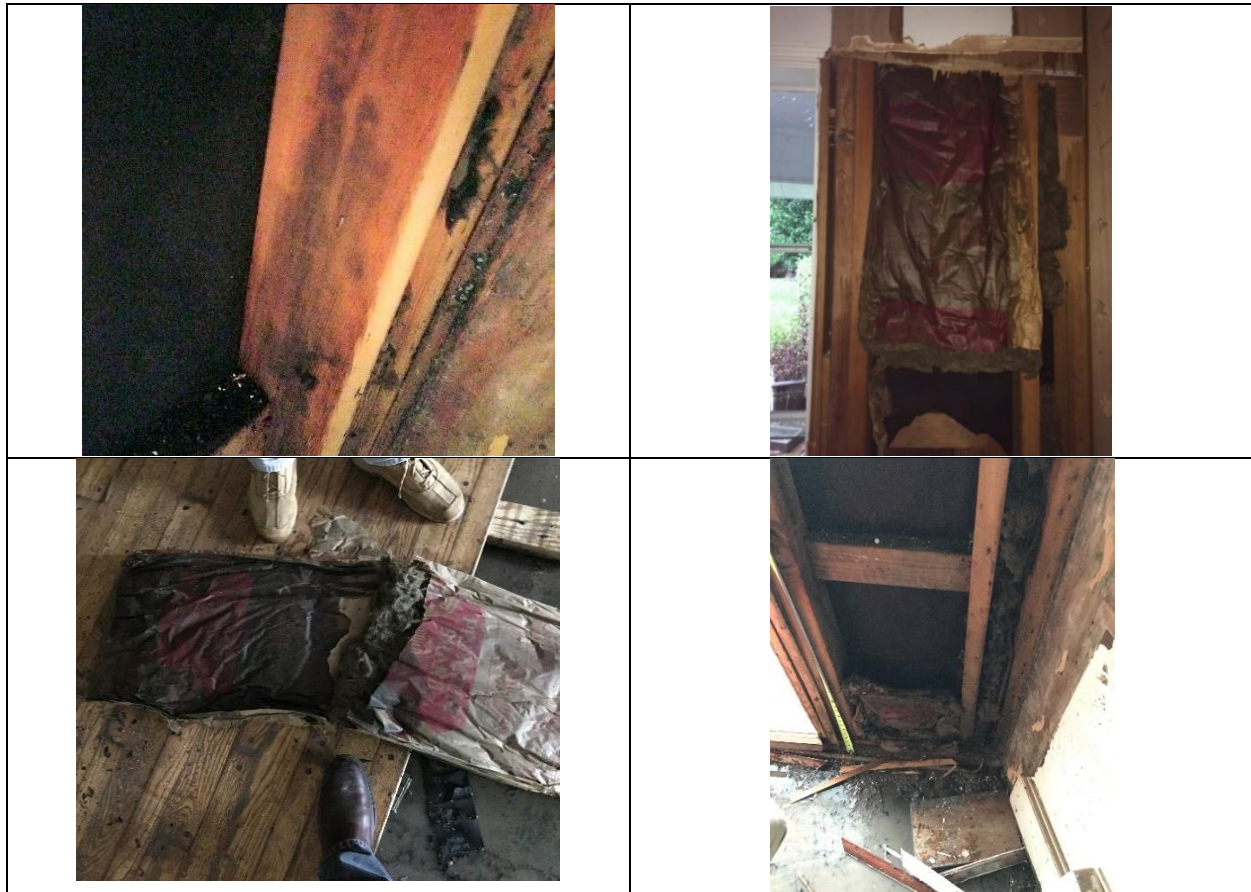
House #6: This house was in the early stages of flooring, gypsum board and insulation removal. The team collected a sample of insulation from a wall the contractor deconstructed specifically for us to sample. The insulation was saturated, but there were no signs of wicking. The T1-11 sheathing was wet and had moderate microbial growth, as did the framing. This house was approximately 100 yards from Buffalo Bayou and suffered extensive flooding to a height of approximately 40 inches above floor grade. Because the flooding was due to rising bayou waters and because the water remained in the home for at least a week, there is a possibility contaminants such as fecal coliform and petroleum residue have been absorbed into the structure of the house. Note the picture below of the insulation batt showing the saturated condition of the batt at and below the water line and the dry condition of the batt above the water line.

Insulation type	Insulation location	Floodwater max height	Floodwater duration	Microbial growth	Sheathing-framing condition
Rock wool Batt	Interior walls	40"	21 days	Moderate on wall framing and sheathing	Wet and intact T1-11

Note transition from wet to dry indicating lack of wicking

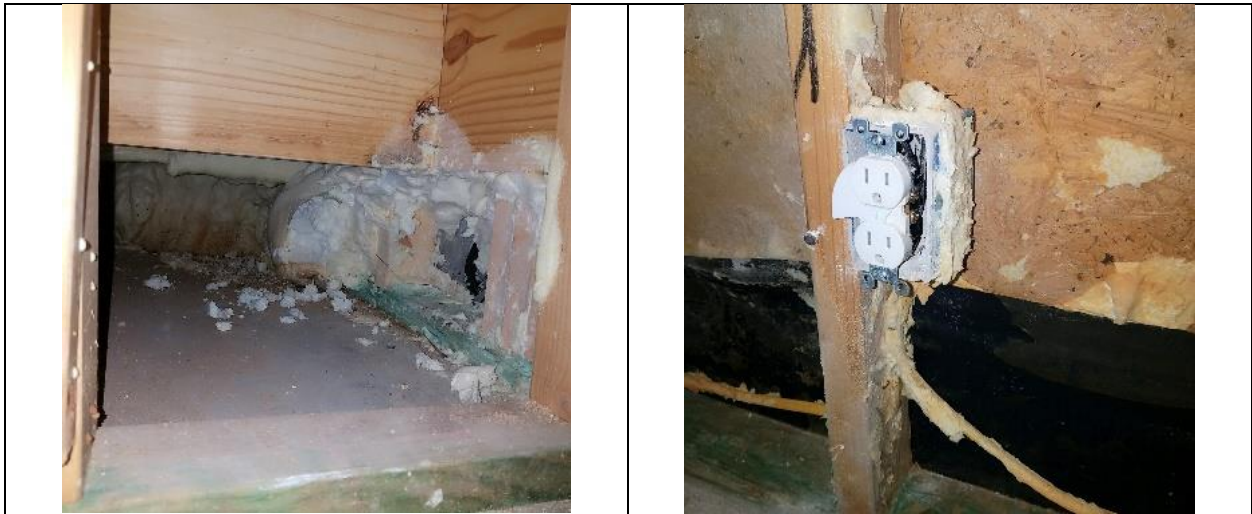
House #7: This house is in the Cypress/Barker area of Houston. The carpet, gypsum board and most of the insulation had been removed. The team was able to collect a sample of wet open cell SPF from the garage wall. The framing and sheathing were wet with no signs of microbial growth. The house had flooded to a level of about 16 inches above garage floor grade. The floodwaters remained in the house for about five days. Gypsum board and insulation were being removed to a level of 24 inches above floor height.

Insulation type	Insulation location	Floodwater max height	Floodwater duration	Microbial growth	Sheathing-framing condition
Open cell SPF	Garage wall	16"	5 days	Not visible	Wet and intact – OSB

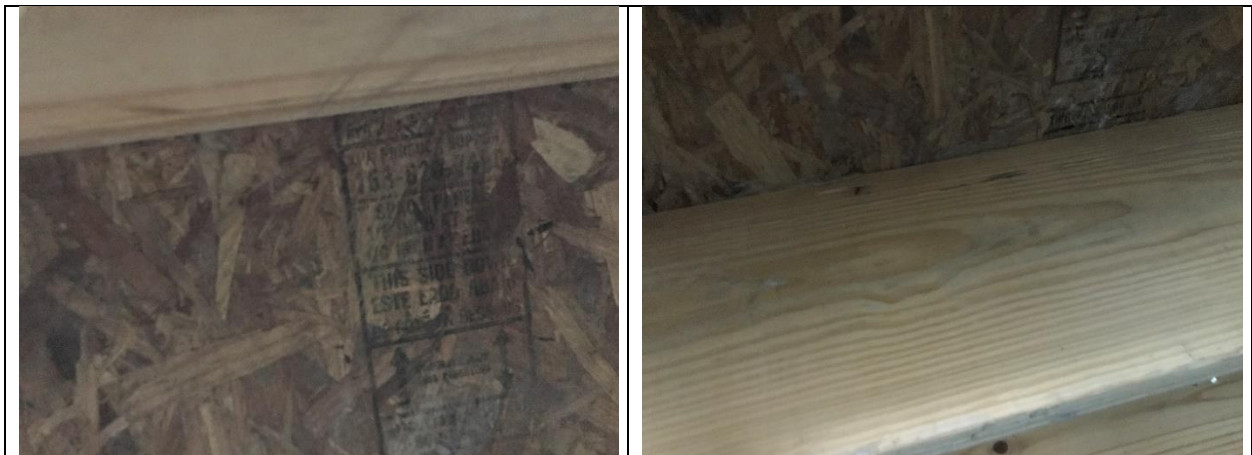
House #9: The homeowner had removed fiberglass batts from the subfloor and garage walls of this house before the team arrived. The framing, wall sheathing and subfloor sheathing were dry and intact with no signs of microbial activity. This new house is elevated above the base flood elevation. The floodwaters, apparently, reached the subfloor insulation but did not damage the finished floor.

Insulation type	Insulation location	Floodwater max height	Floodwater duration	Microbial growth	Sheathing-framing condition
Fiber glass batts	Garage wall/subfloor	Unknown	Unknown	Not visible	Dry and intact -plywood

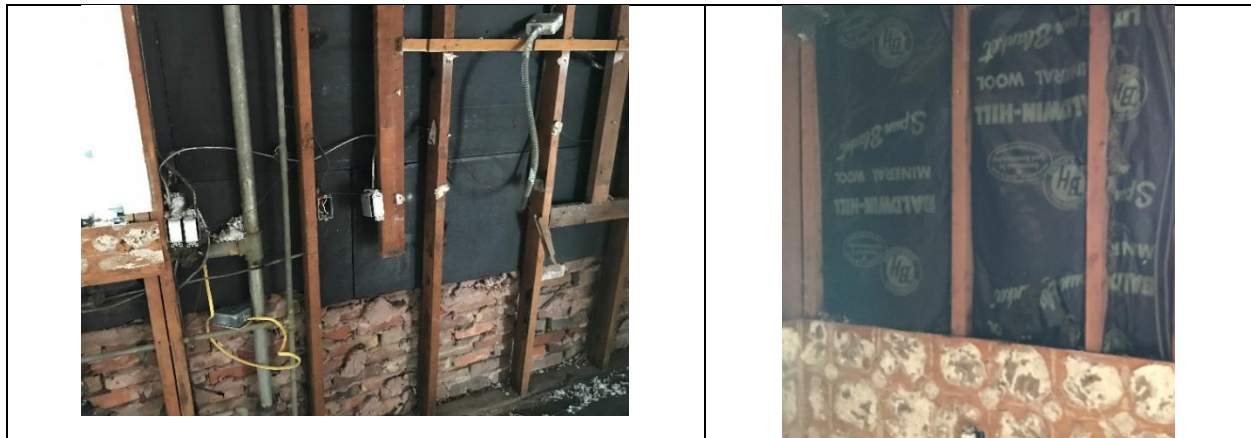
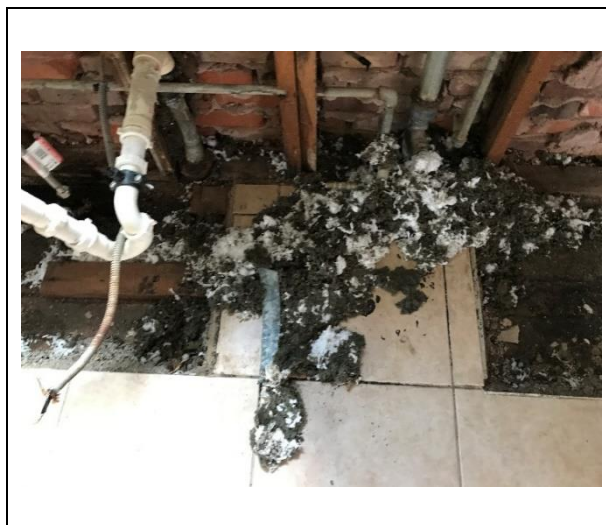
House 10: This house is adjacent to house #5 and similar in construction to that house except that in this house rock wool insulation was used in the walls instead of CC SPF. The same contractor was remediating both houses and had removed the rock wool insulation before the team arrived. The framing was dry and showed no signs of microbial growth. However, the exterior gypsum board sheathing had sustained water damage and been removed.

Insulation type	Insulation location	Floodwater max height	Floodwater duration	Microbial growth	Sheathing-framing condition
Rock wool batts	interior walls	approximately 27"	7 days	not visible	framing dry and intact, sheathing removed
